American Squalor: A Case Study in Combating Low-Quality Housing Construction

David Kennedy¹[0000-0003-4791-5550], Alyssa Kuhns¹[0000-0002-5729-1502]

¹University of Arkansas, Fayetteville, USA

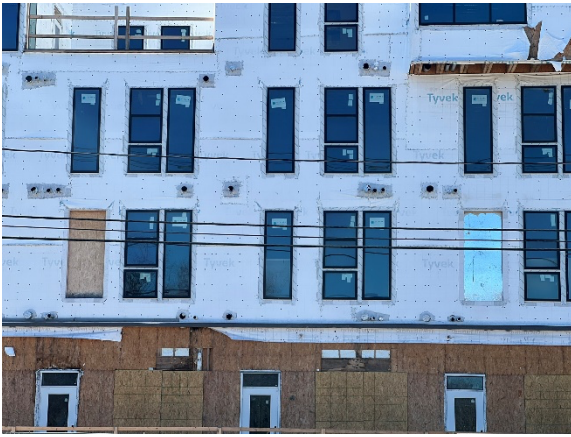
Figure 1: Incomplete multi-family construction on indeterminate hiatus in Northwest Arkansas. While they have latent potential for completion, the low-quality materials deployed cannot withstand long-term exposure. Source: (Author 2023)

In Fayetteville, several developments have paused work – in some cases for years at a time. Developments, like those seen in Figure 1, sit partially completed and exposed to the elements for months or years on end. During this time, structured and material performance is comprised, and product warranties are voided. If work resumes, previously completed work is deconstructed and materials replaced, a process that further increases labor and material costs. In the Fayetteville area, as is the case in many mid-sized cities, there has been an increase in out-of-state developers of large multi-unit housing developments. While these developers bring with them knowledge and expertise, they also lack a vested interest in the area. What results are non-site-specific and non-regional-specific developments void of contextual responses through architectural massing or material.

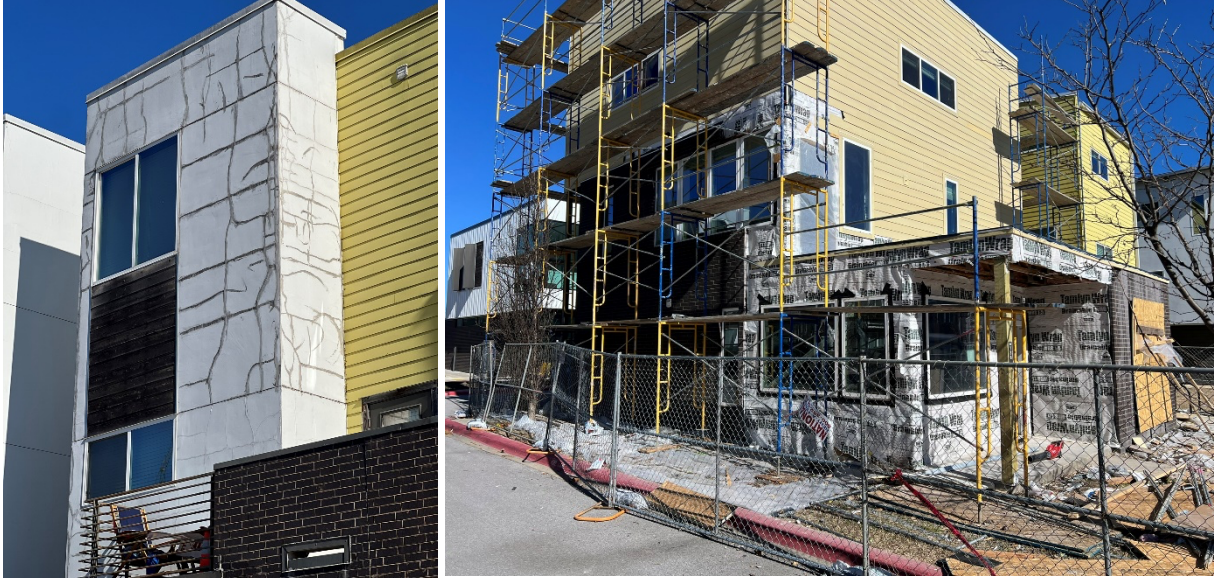
Figure 2: (Left) Envelope failures of typical new, market-rate housing construction in Fayetteville, Arkansas. Even when these failures permit continued occupancy of the structure, they degrade its value potential and portend more significant failures in the future. (Right) A typical, poorly constructed housing structure undergoing invasive repairs. The rapidity of construction, coupled with low-grade materials, catalyses building failures and triggers the need for repairs. This incurs extra expense, pauses revenue generation for the development’s owners, and takes an otherwise beneficial housing unit off the market. Source: (Author 2023)

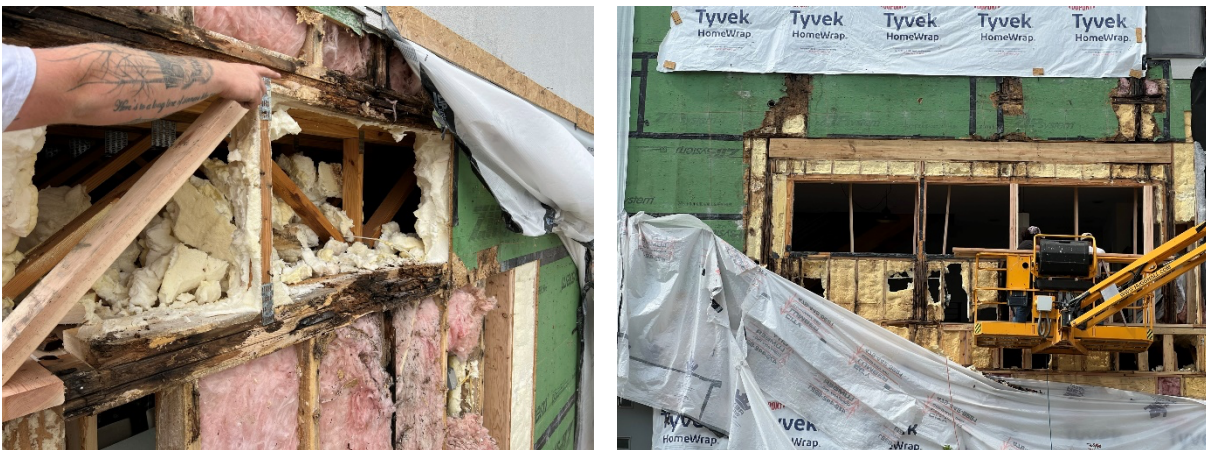
In assessing the structure's integrity from the interior, the extent and severity of the damage left even erudite contractors shocked. Critical studs at window edges were left rotted and friable along their length and at their bases – precisely where the walls' weight from above aggregated (Figure 3). The plywood sheathing, attached to the studs' exterior, was in some places so badly rotted that it had dissolved into flakes mounded at the bottom of wall cavities. The most deleterious, if not readily visible, damage was to the metal lath mesh, whose sole task was to support the cementitious stucco on the exterior. In places, all that remained of the lath was its imprint on the interior side of the stucco – a shadow of something long rusted away by moisture. While the stud and sheathing degradation presented existential risks for the structure, the more consequential issue was the absence of metal lath: thousands of tons of the cementitious stucco could at any moment slough off onto unsuspecting bystanders. The extent of the damage made two facts evident: that a significant amount of the structural components needed to be replaced, and that doing so would require removal of all exterior cladding.

Figure 3: Water infiltration through the cladding and windows likely occurred for the life of the building. The polyurethane insulation is largely removed in this image to expose rotting structure, but its presence would have trapped the water, encasing susceptible wood members. Blackened structural members were completely friable; the material in this image was easily crumbled by hand. Sheathing and metal lath had completely disintegrated prior to demolition of the exterior cladding, making plain both the magnitude of the issue and the dangers it presented to human health and safety. Source: (Author 2023)

Clearly, exterior cladding dependent on failing structure could not be kept in place. More, cladding dependent on structure of indeterminate solvency needed to be removed, if only to determine the status of the structure behind. The decision was made to remove all cladding from the structure, including brick veneer, stucco, and cement board. In doing so, the windows would also be removed, though they could be returned to their openings. New cladding would be installed following structural repairs, but its type and configuration would be dependent on identification of the sources for the offending failures. In effect, removal of the cladding was a forensic exercise, permitting identification of the design and constructive failures that catalyzed the damage.

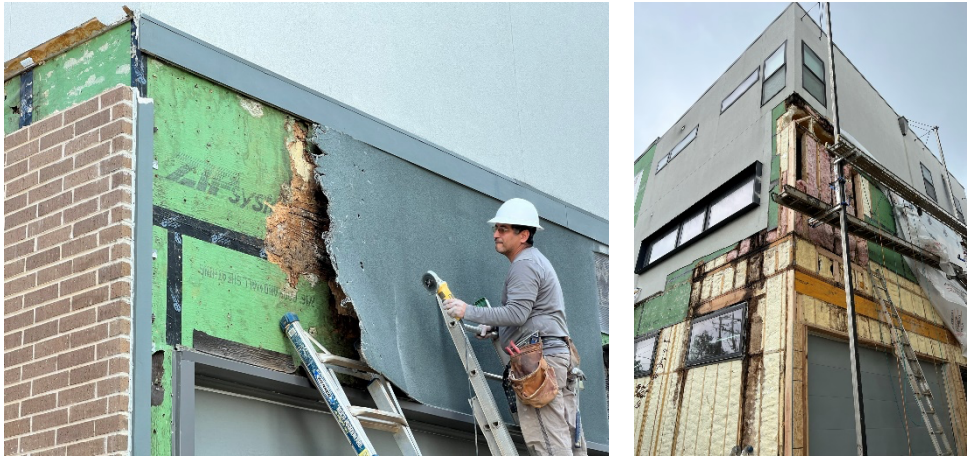
From a technical standpoint, the building envelope and structure issues stemmed from a litany of detail failures. The integrated sheathing, a materials system designed to act as both structure and water-resistive barrier, proved the venue for many of these. By itself not problematic, three systemic installation errors caused widespread failures in the sheathing. For one, the nails used to attach the sheathing to the studs were universally over-driven. At each nailing point, the nail head breached the integrated sheathing's weather-resistive barrier, creating a pathway for water to reach the moisture-sensitive wood composite beyond. The building code and the manufacturer requirements indicated about 88 nails per sheet, and, with an estimated 200 sheets distributed across the structure, this error created 17,600 opportunities for water infiltration. A second failure occurred at the seams between sheathing panels, where the proprietary sealant tape was not adequately adhered, permitted more water intrusion at the panels' vulnerable edges (Huber sheathing 2023, 17-19). The third sheathing-based failure arose from the improperly installed stucco cladding. Both the building code and the manufacturer instructions expressly required

an additional layer of weather protection between the sheathing and the stucco, and this was not installed, reducing the system's effectiveness (Huber stucco 2023, 1). Moreover, the nails used to attach the stucco's metal lath were too long, fully penetrating the sheathing and creating a moisture pathway into the cavity, and they did not have a "furring" head, as required by the manufacturer, to suspend the metal lath away from the sheathing. The stucco application itself was thinner than the 3-layer, 22mm (7/8 in)-thick requirement stipulated by standards (Melander 2003, 18-22). Its thinness permitted more rapid water propagation through the assembly and greater chances of a water-logged cladding. Once there, the absorbed water had several options for penetrating the barrier (Figure 4).

Figure 4: Stucco (i.e., portland cement plaster) comprised the plurality of facade materials. Its installation did not adhere to requirements established by building code and standards, dooming the defenseless wood structure behind. In the left image, damaged sheathing is exposed beneath the stucco. Where the yellow polyurethane insulation is visible, the sheathing has completely disintegrated. Source: (Author 2023)

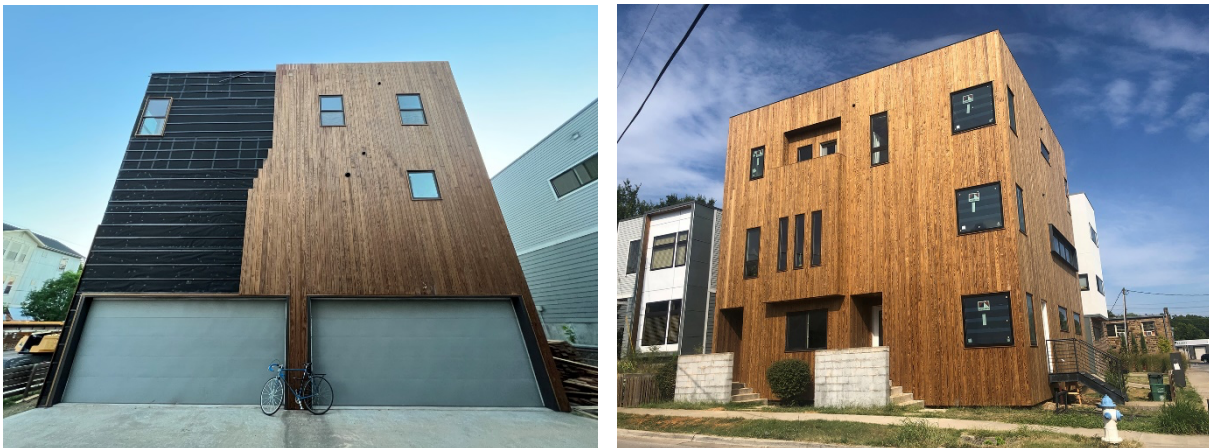
Figure 5: On the left, the non-adhesive, weather-resistive barrier and furring await coverage by the wood rainscreen. On the right, a corner perspective image of the completed building. Source: (Author 2023)

The established strategic objectives yielded a singular, feasible solution that met the performative and constructive imperatives of the project. Following cladding demolition and structural stabilization, new, non-integrated sheathing was installed. Over this, a vapor-permeable, non-adhesive weather resistive barrier was installed, followed by horizontal cellular furring strips. Thermally-modified, 19mm x 140mm (nominal 1x6), Southern Yellow Pine boards were then attached in a vertical orientation using stainless steel screws. The simplicity of this installation process provided two significant benefits for the project: the system could be accurately installed regardless of the laborer’s skill level, and the system could be deconstructed with the same level of skill and simplicity. Most importantly, the new solution acutely avoided the sources of failure found in the initial scheme, ensuring that the catastrophic damage wrought by that flawed system could not recur.
